CONNECTICUT RIVER BASIN
VERNON, CONNECTICUT

PAPER MILL POND DAM
CT 00621

**PHASE I INSPECTION REPORT
NATIONAL DAM INSPECTION REPORT**

Identification No:	CT 00621
Name of Dam:	Paper Mill Pond Dam
Town:	Vernon
County & State:	Tolland, Connecticut
Stream:	Hockanum River
Date of Inspection:	March 10, 1981

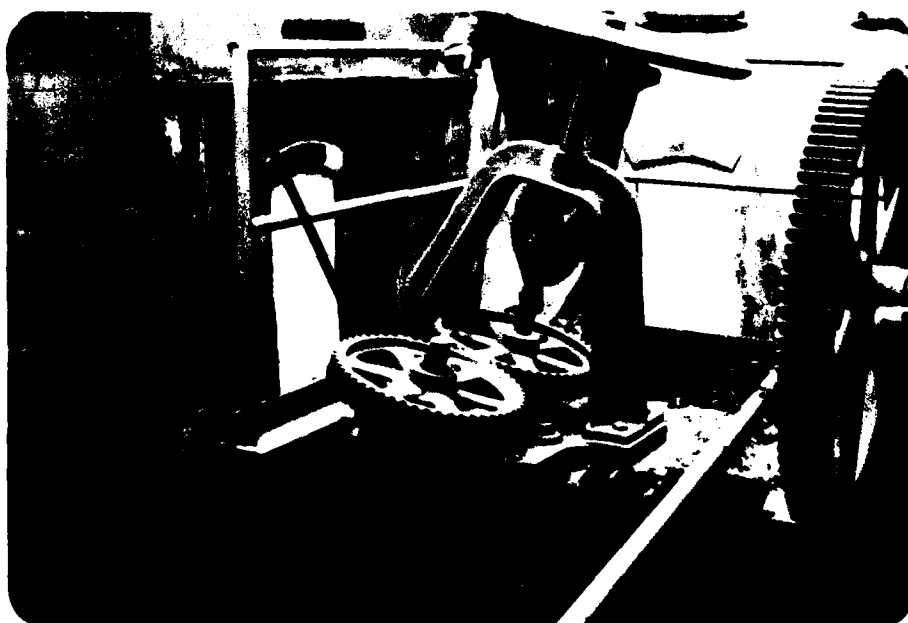
1. Upstream Face - The portion of the upstream face that is visible appears to be in good condition. Attached to the upstream face is the control mechanism for the drawdown outlet as shown in Photo C-8. This face should be inspected with the water level lowered.

C-8 OUTLET CONTROLS
